Manhole Inspection Summary

Manhole # S21GG_032MH

Insp Date: **6/27/07 9:08 AM**

Location Address: **1426 BRUCE ST** Cross Street: **PRESSTMAN ST**

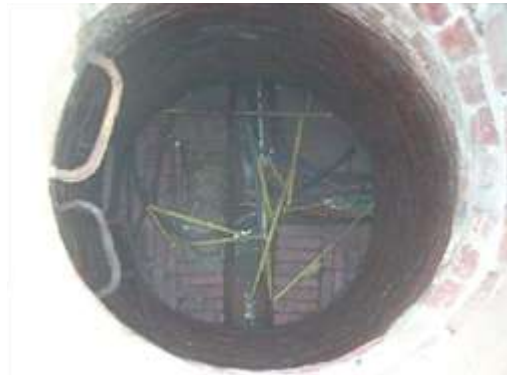
Top View

DEBRIS ON BENCH

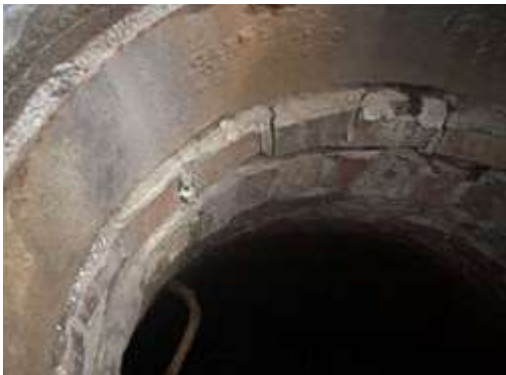
Defect 2

Chimney / Frame Adjustment ☒ Exists Material: **Brick** ☐ Parged Height: **3** (in.)
Condition: ☐ Sound ☒ **Cracked** ☐ Root Intrusion ☐ Loose Brick ☐ Deteriorated
Infiltration: ☒ None ☐ Joint ☐ Cracks ☐ Mortar ☐ Roots ☐ Wall

CRACKED CHIMNEY

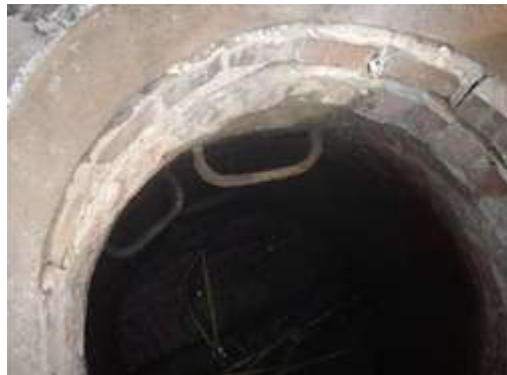
Defect 1

Steps Count: **4** Missing: **0** ☒ **Corroded**

CORRODED STEPS

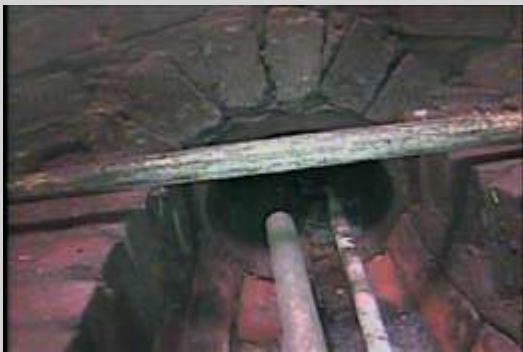
12 O'Clock Outflow

DEBRIS IN CHANNEL

Pipe Height: **8.4** (in.) Rod and Bar (Angled)
Pipe Material: **Clay** ☐ Pipe Lined
Invert Depth: **9.11** (ft.) Flow Characteristics: **Slow**
Deposits: ☐ None ☐ Mud ☐ Sludge ☒ **Debris** ☐ Grease
Silt Depth: **2** (in.) Deposits Extent: **Light**
Infiltration: **None** Pipe Seal Cond: **Sound**

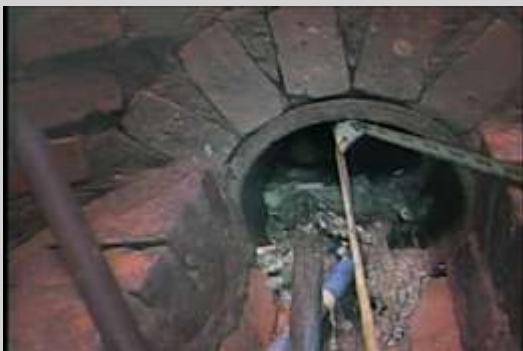
3 O'Clock Inflow

DEBRIS IN CHANNEL

Pipe Height: **8.4** (in.) Rod and Bar (Angled)
Pipe Material: **Clay** ☐ Pipe Lined
Invert Depth: **8.72** (ft.) Flow Characteristics: **Slow**
Deposits: ☐ None ☐ Mud ☐ Sludge ☒ **Debris** ☐ Grease
Silt Depth: **5** (in.) Deposits Extent: **Heavy**
Infiltration: **None** Pipe Seal Cond: **Sound**

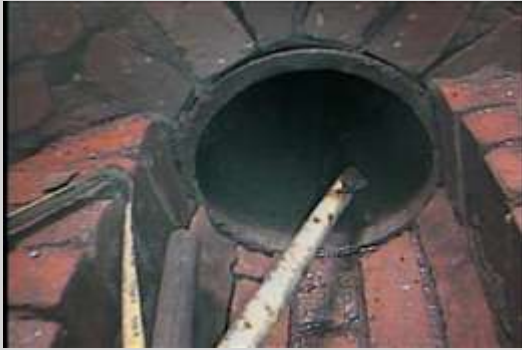
6 O'Clock Inflow

Deposits: ☐ None ☐ Mud ☐ Sludge ☒ **Debris** ☐ Grease

Silt Depth: **1** (in.) Deposits Extent: **Light**
